# Spontaneous Breakages in Tempered Glass

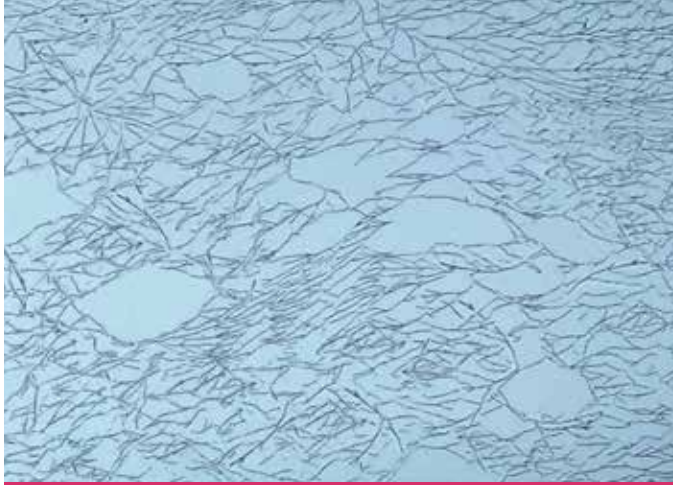
**Image 1: Breakage due to uneven tempering**

the stress differences on the same pane of glass are very large and this can be easily identified from such breakage. The breakage pattern will be highly non-uniform with some large islands of non-fragmented glass, enclosed or surrounded by much smaller fragments. (See Image-1)

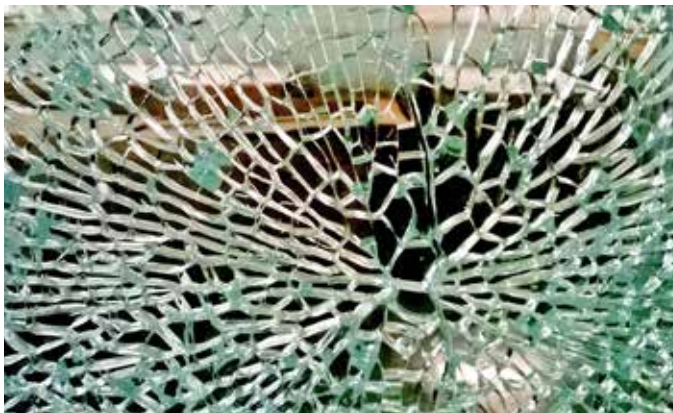
**Image 2: The origin of breakage, caused by Nickel sulfide inclusions**

the shape of wings of the butterfly. (see image-2) This is often called 'butterfly pattern' or 'double D Pattern'. The origin of breakage is generally away from the edge of glass.

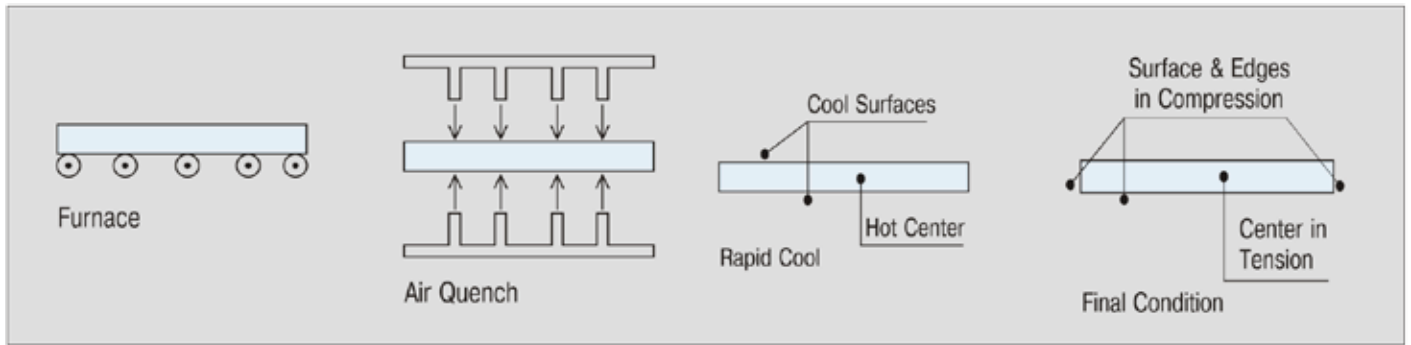
**Diagram 3a: Process of Tempering**

large sheets of annealed glass are cut to the appropriate sizes and shapes. The edges are ground and any holes or cutouts required in the panels are created. It is then heated in a furnace to a temperature of 600-700 degrees C. This temperature is held until the glass softens slightly, at which time it is rapidly cooled through the use of air jets, a process called quenching. Quenching reduces the temperature of the surfaces of the glass quickly and significantly, but due to the low thermal conductivity of glass, the core of the panel remains at a much higher temperature. As this core

cools, it induces compression in the already-cooled outer layers, and a balancing tension force is formed in the core of the panel. (See diagrams –3a and 3b)

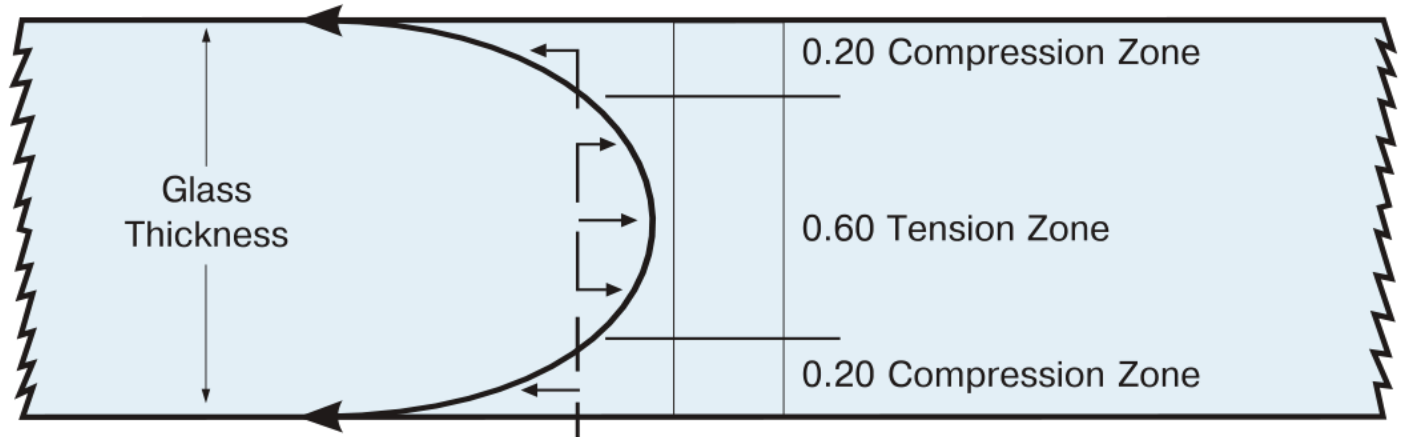
**Diagram 3b: Stress Distribution in Tempered glass**

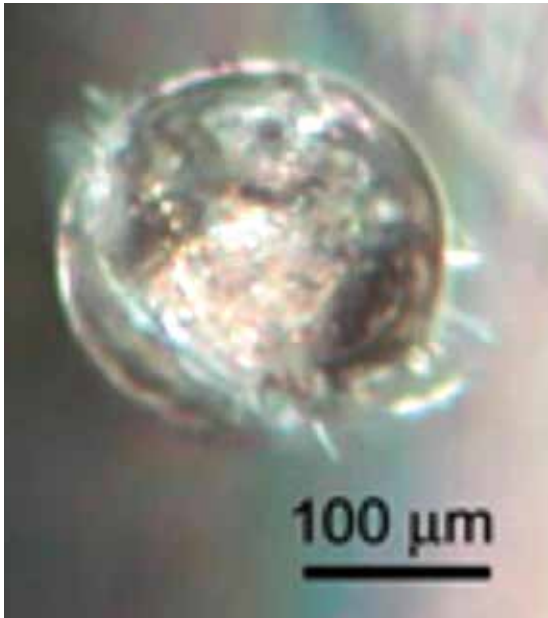
*Image 4: NiS Particle causing Micro Cracks*

Once the glass cools past the phase change temperature, the NiS inclusion seeks to re-enter its lower energy beta-phase. For “trapped” inclusions, this process takes anywhere from months to years. This expansion creates localized tensile stresses that are estimated to be as high as 125,000 psi (860 MPa) at the glass-NiS Interaction surface. The magnitude of this stress drops off sharply away from the face of the inclusion, but is sufficient at the face to cause micro-cracking. (See image 4 and 5).

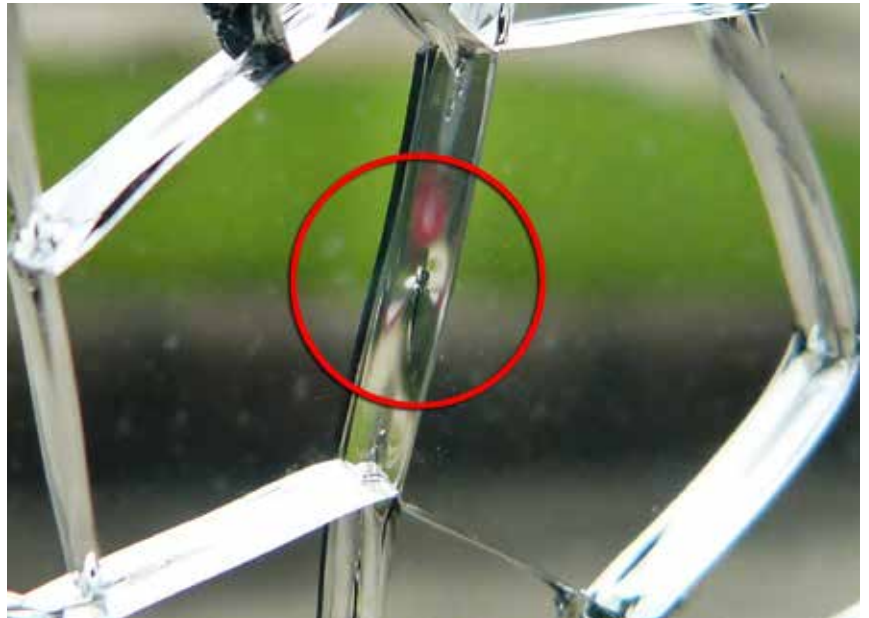
*Image 5: NiS Particle photographed after spontaneous breakage*

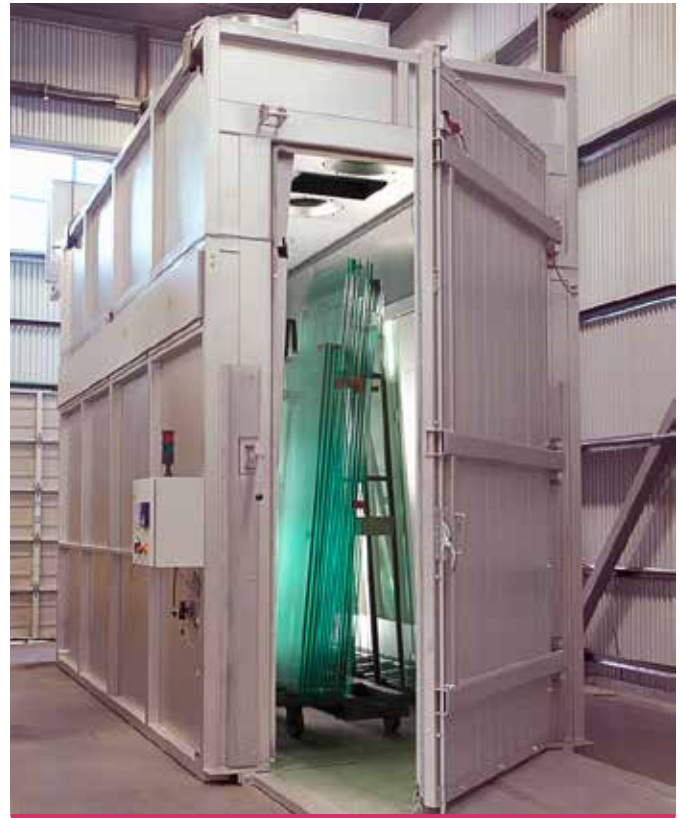
*Heat Soak Oven*

**Heat Soak Testing:** Tempered glasses can be heat soaked by heating the glass panels for a third time to a temperature below the phase change temperature of NiS and maintaining it or soaking it

at that elevated temperature for a set time. Maintaining an elevated temperature facilitates faster conversion of any particle of NiS, if present, from alpha-phase to beta-phase, and therefore the idea is that any panel, which has a possibility of failure from NiS, should fail in the HST oven rather than on the building. The process was introduced in 1982 and the first standard that evolved was DIN 18516. The most common standard, currently being followed is EN 14179. This standard requires glass to be heated to 290 °C and held at this temperature for 2 hours, which is a shorter duration than 8 hours for DIN 18516. The reduction in time was based on recommendations from research, which indicated that less than 1 break in 10,000 panes of glass was expected to occur after 2 hours.
